# TBILISI CHESS PALACE AND ALPINE CLUB

## CONSERVATION MANAGEMENT PLAN

TBILISI 2021

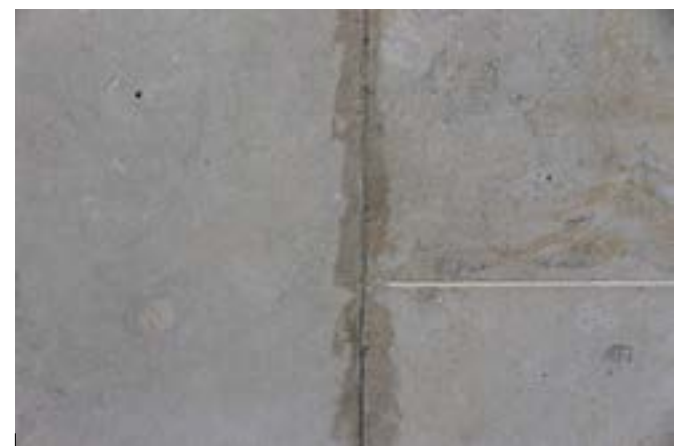
Replaced stone cladding of the façade in 2018.

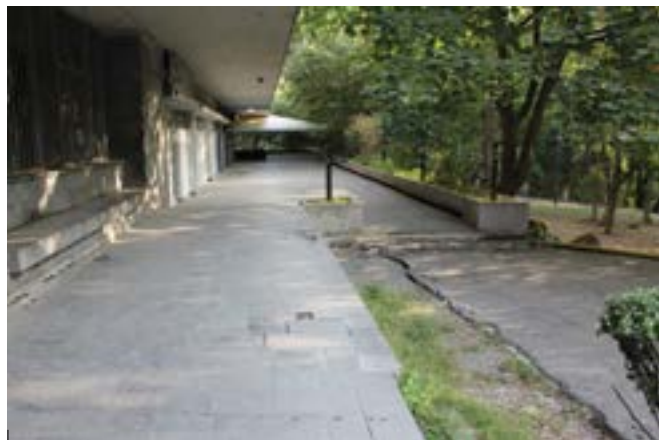
A Terrace on the Basement Floor. East Side of the Building. 2018

The damage is linked to the infiltration of atmospheric precipitation, caused by the wrong location of water diversion pipes on the roof and balconies, as well as the absence of drainage and runoff water channels.

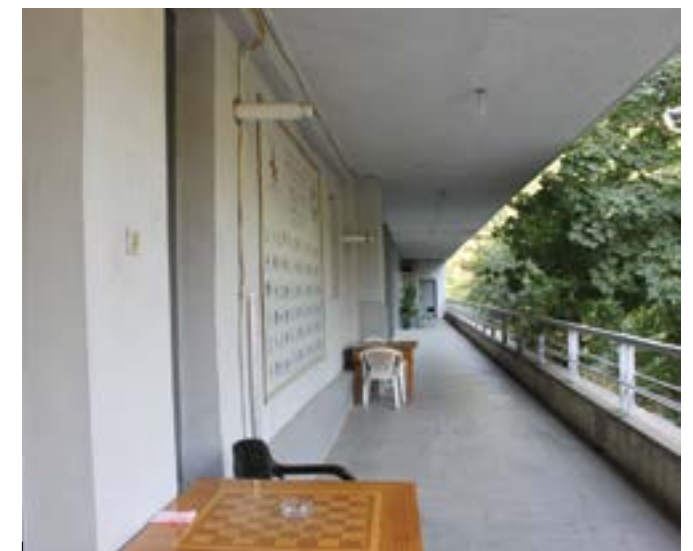
Balcony on East Façade. 2018

**Metal Railing** - the balcony's metal railing is slightly deformed, in some places - corroded, and small sections are removed from it.

The causes of damage, as in many other cases, is the lack of proper and continuous maintenance and improper repair works. For these reasons, the balconies are not protected against the aggressive impact of environmental factors. One of the reasons for their deformation can be the movement of concrete casting material during construction and soil settlement, another reason presumably is the presence of new additions and the impact of their weight. The traces of rainwater, existing on the ceiling are most likely caused by the absence of the drippers on the edges of balconies and in some cases their incorrect location.

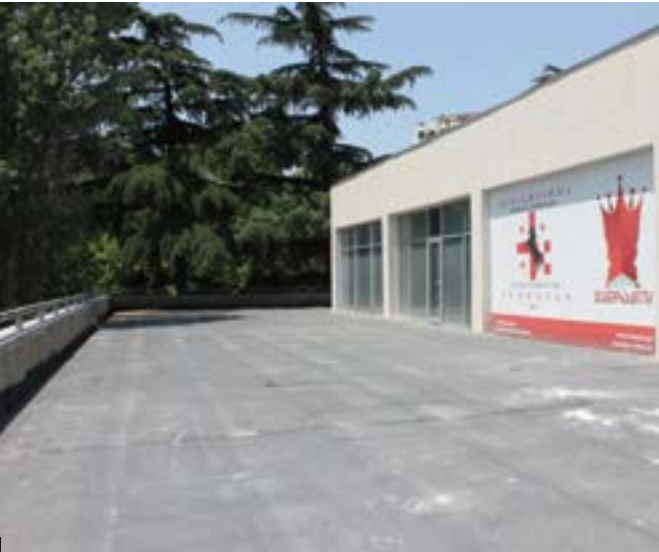
Roof Terrace. 2019

The damages are mainly caused as a result of atmospheric (exposure to water, frost, and sun), as well as mechanical impact and improper use.

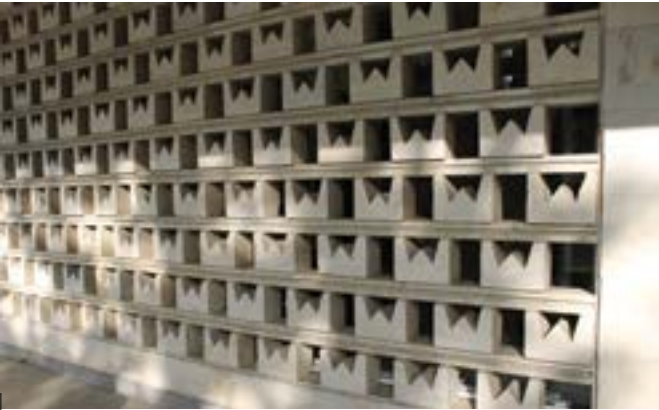
Decorative Stone Wall

The cause of damage on the decorative limestone wall, in almost all cases, is of mechanical/physical character. Other causes are: Lack of maintenance and vandalism.

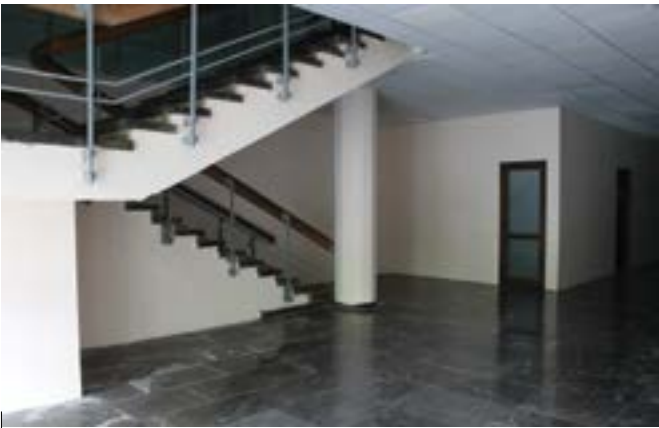
Tuff tiles cladding of the column covered with paint layer. 2018

Stone cladding was damaged due to improper use and inadequate intervention. The occurrence and development of damages as a result of the lack of maintenance are also evident.

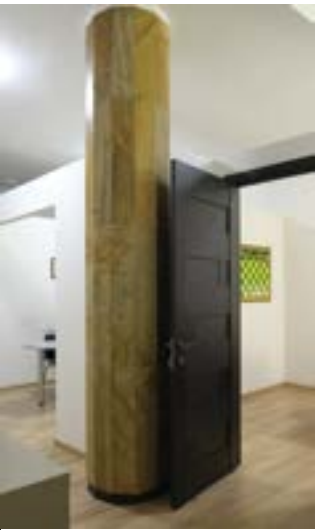
Tuff tile cladding of the column covered with the layer of varnish. 2018

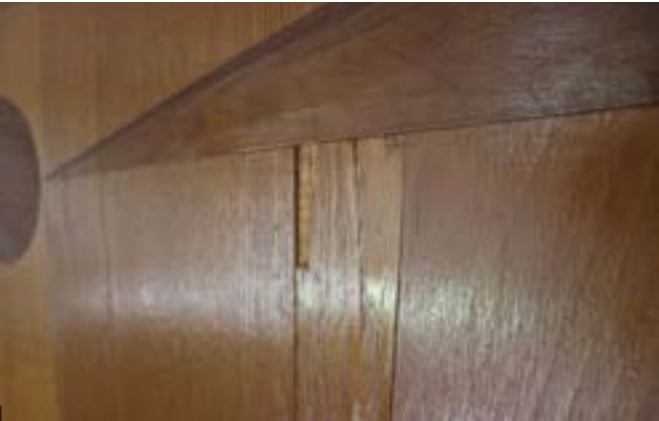
The leading cause of damage to the walls and panels is improper use and inadequate intervention. Failure of the roofing layer and rainwater disposal system caused water infiltration into the walls and led to damage. The traces of mechanical impact are also evident.

Surface Damage on Vertically Slidable Marquetry Panels

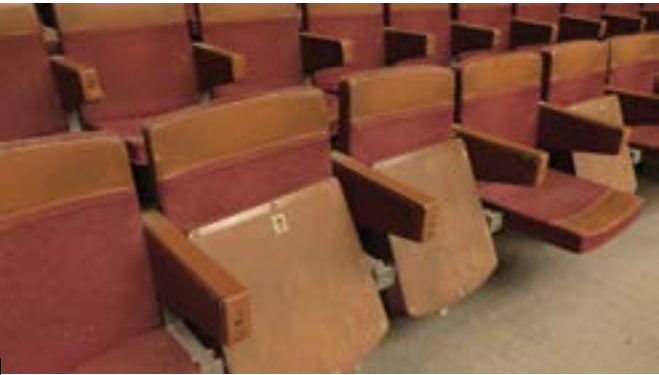
Chairs of the Main Hall

Lack of maintenance, age and wear, and improper exploitation.

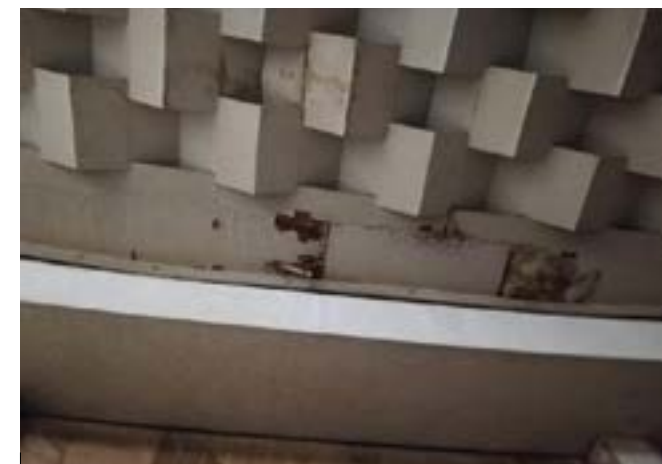
Fig. 21 The suspended ceiling in the Main Hall, damaged by roof leaks
