# TBILISI CHESS PALACE AND ALPINE CLUB

## CONSERVATION MANAGEMENT PLAN

TBILISI 2021

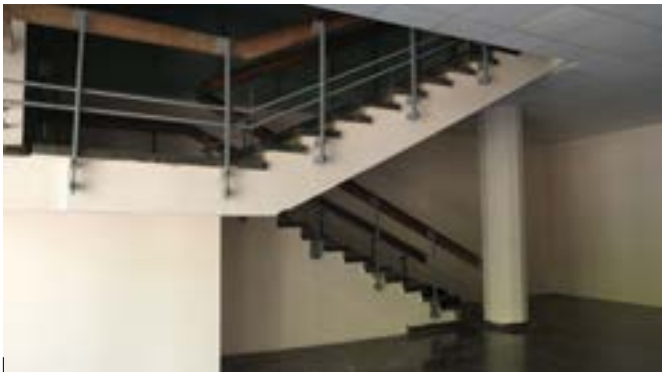
Staircase in the northwest of the interior. 2020

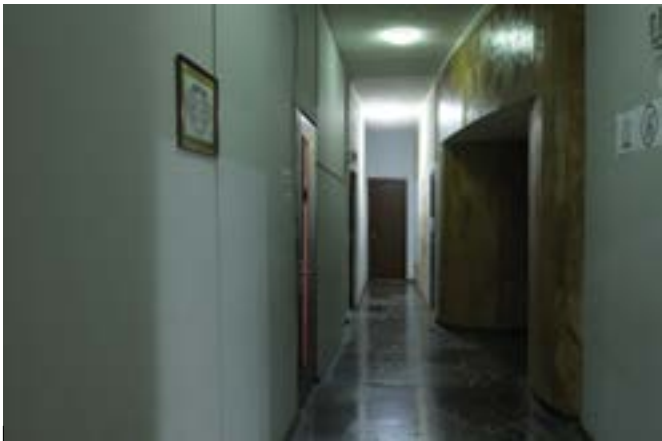
The dramatic change of planning and inadequate use of space is evident on the first floor of the building. This change is related to the division of the central vestibule and gallery space into individual rooms with various new functions.

Vestibule on the eastern side of the first floor. 2020

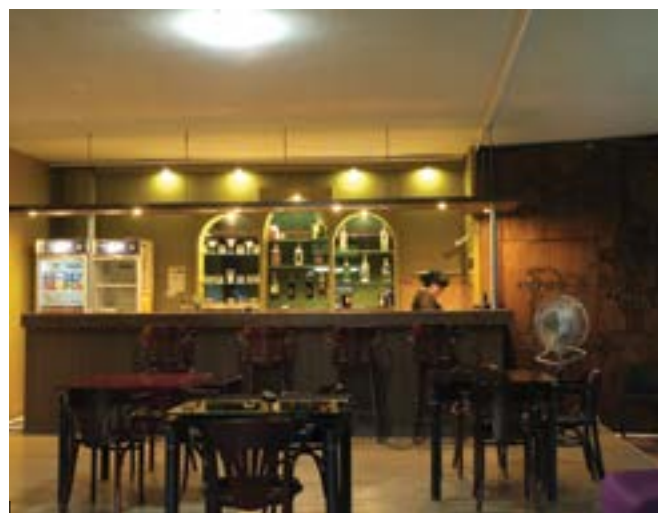
*North-east part of the building where the staircase was located. 2020*

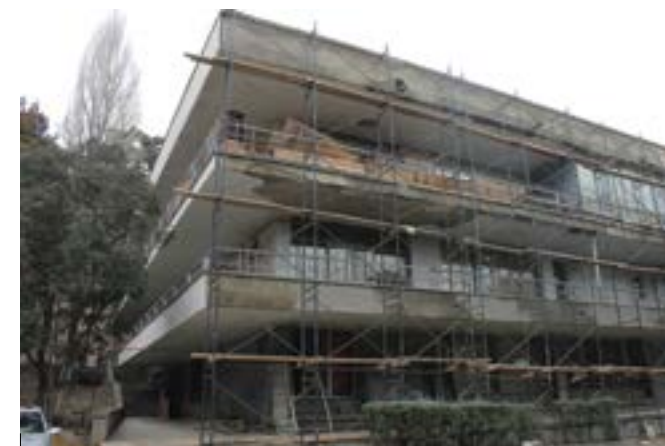
In the framework of the rehabilitation works, the major part of the original *Eklari* stone cladding was removed and replaced with thinner material of the same type.

were filled with inappropriate filler and processed with a multifunctional electric cutter, causing mechanical damage to the stone surface.

Process of replacing stone cladding on east façade. 2018

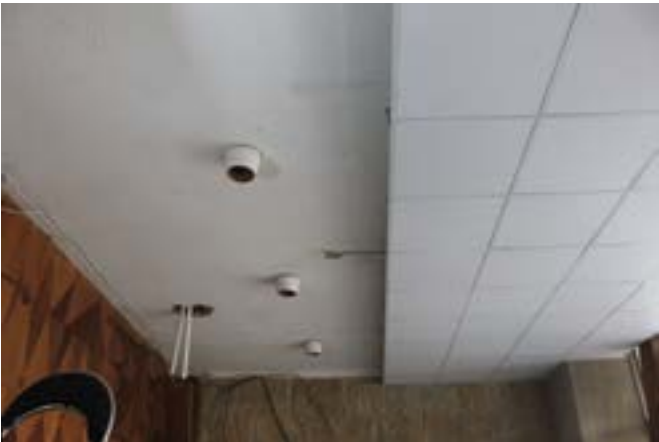
In the vestibules of the first and second floors, the walls were covered with plasterboards which then were painted with modern acrylic paint. Dropped ceiling tiles were used as the finishing of the ceiling, as a result, the original ceramic lamps were concealed.

Process of Arrangement of Dropped Ceiling. 2018

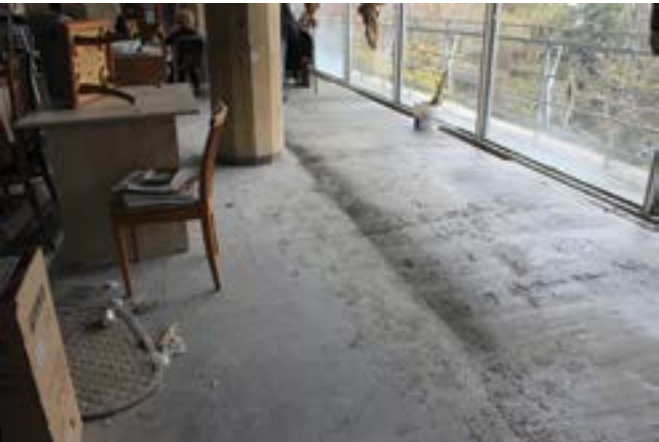
In the side galleries of the second floor, in the halls (initially representing a wide vestibule), the black marble floor was covered with modern laminate flooring. To enlarge the hall, located on the eastern side, part of the balcony was added to the interior; for this reason on original basalt tiles cement screed was arranged and laminate flooring was laid. In the same spaces (both galleries on the second floor) the original plinths of the same period as the columns, finished with marble tiles, were replaced with modern, profiled plastic plinths.

The Process of Expanding the Eastern Gallery

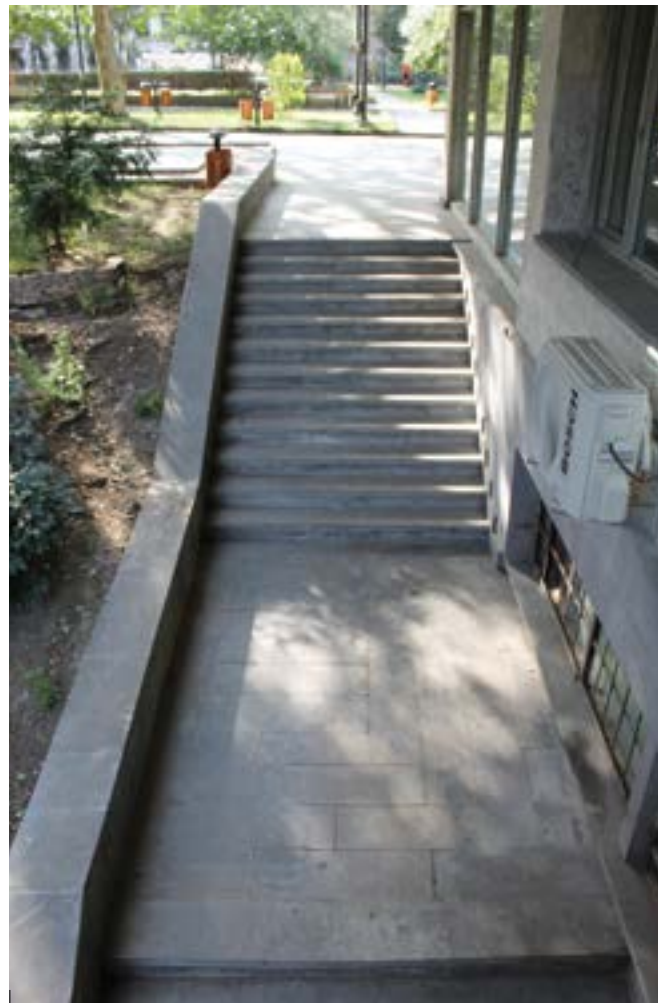
In the middle part of the northeastern and northern façades of the terrace the paving is lowered (the ground is settled). Cracking and breaking of individual stones are also observed.

The damage is linked to the infiltration of atmospheric precipitation, caused by the wrong location of water diversion pipes on the roof and balconies, as well as the absence of drainage and runoff water channels.

A Terrace on the Basement Floor. South of the Building. 2018

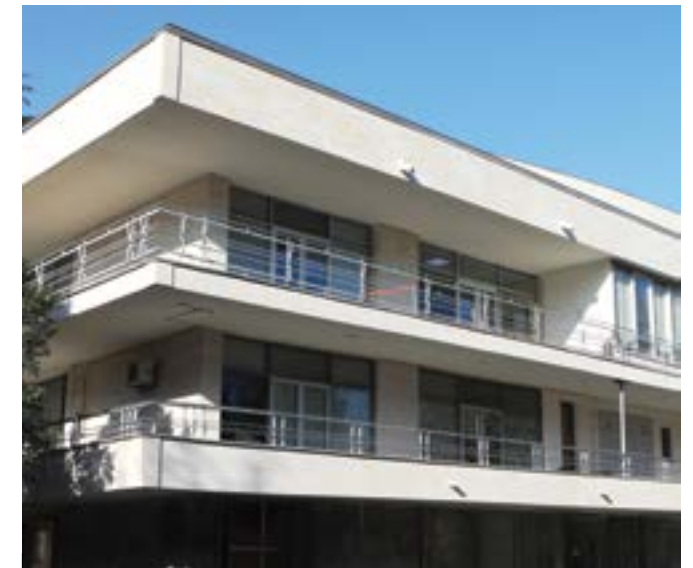
Renewed Stone Cladding on the East Façade.

**Cladding** - In some places, stones are coming loose; the original laying of the stone cladding was altered (thinner stone slabs were used, and the technique of attaching them to the support is unauthentic and wrongful). The three-row stone cladding pattern on the balcony parapet shield, on the

first floor, is replaced by new, two-row cladding. Their height is also increased at the expense of their alignment on one line. The surfaces of the majority of old tiles are scaled and delaminated.

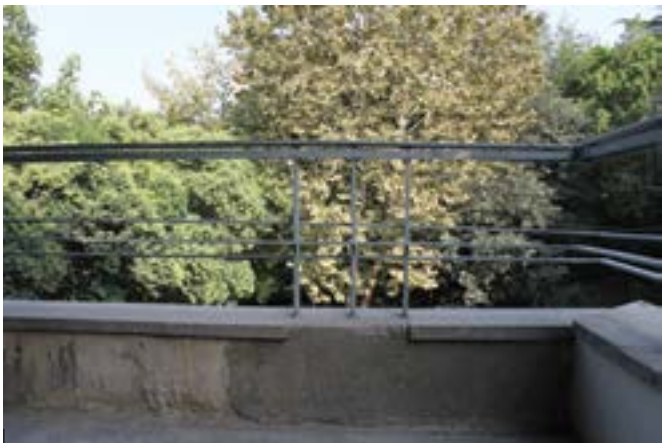
**Metal Railing** - the balcony's metal railing is slightly deformed, in some places - corroded, and small sections are removed from it.

Metal Railing. 2018

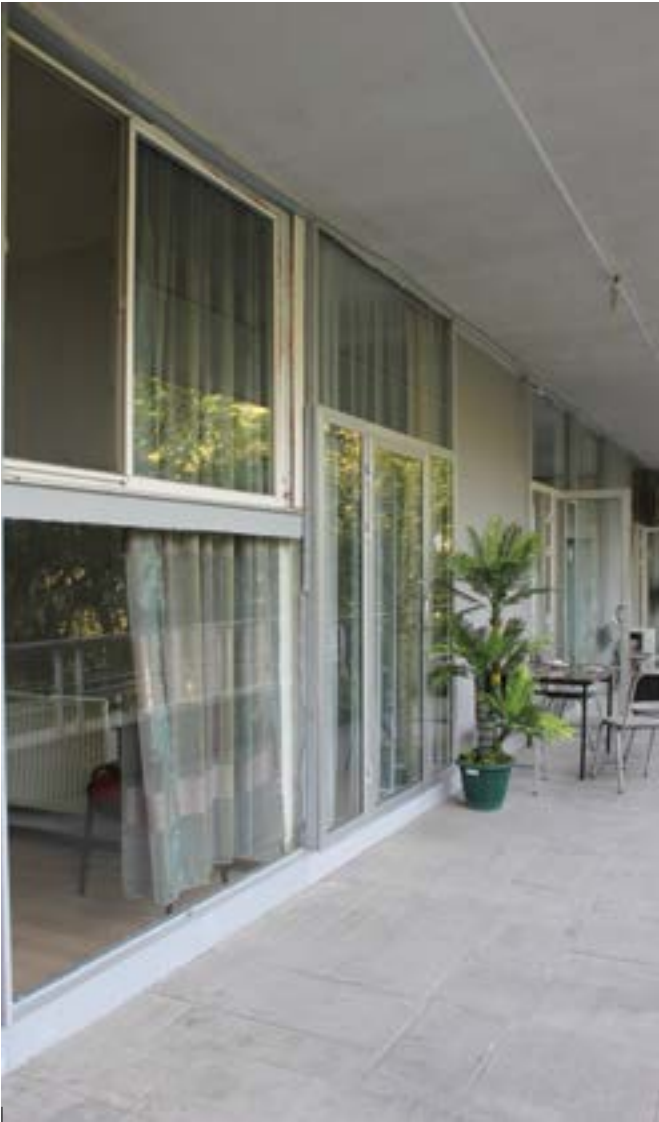
Aluminum Vitrages. 2019

The majority of the preserved original profiles have only minor damages, expressed in localized (spot) deformation-buckling. Part of the profile is lost, part is painted or altered.

Lack of maintenance, improper use, and mechanical impact. Improper installation of individual elements also occurs, which could be leading to the penetration of atmospheric precipitation or wind into the interior.

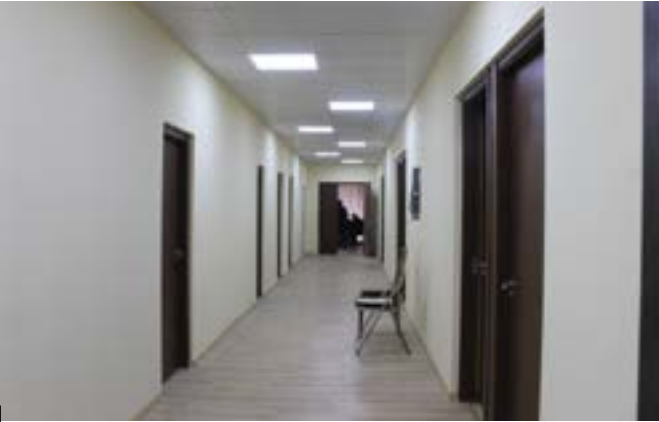
All internal original doors were replaced with the modern, so-called medium-density fibreboard (MDF) doors.

Administrative Zone of the First Floor. New MDF doors

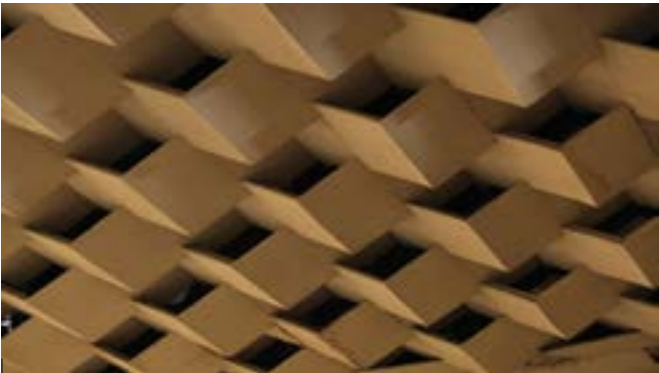
Ceiling of the Main Hall. 2019

**Ceiling** – The significant part of the wooden panels of the ceiling structure is sound. No losses or significant mechanical damage are observed. Only in one section, in the northern part of the Hall, there is damage caused by water infiltration, in particular – localized rotting of wooden panels and flaking of the paint layer on the surface.

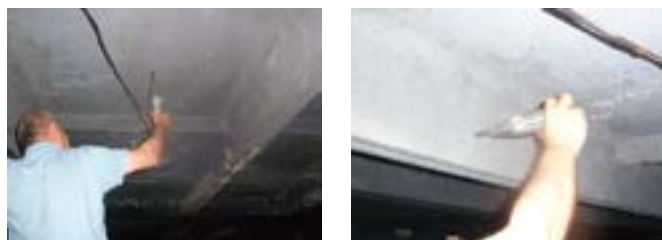
Fig. 22,23. Identification of concrete grade in ribbed slabs of roofing

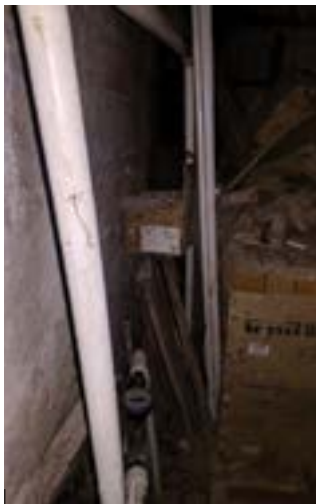
fig. 3

The picture shows that the steel pipe is very corroded. It is always moist on the outside because of condensation; interaction with air further corrodes it. It does not have an anti-corrosion cover and, after its cutting and blocking, highly corroded areas are visible at the points of welding.

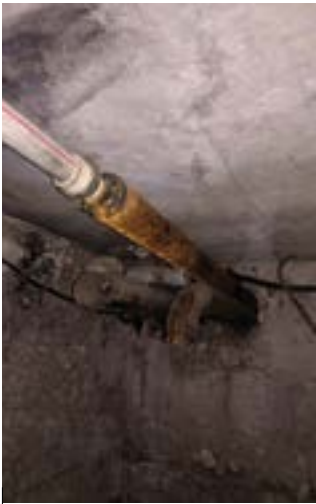
fig. 6

The basement itself consists of several individual halls, which are not connected with doorways. There is only one small opening, a hole made in the wall of ground and concrete, in which only a thin, flexible person may fit through. There are several smaller holes for pipes and cables (see fig. 4, 5, and 6).

As it was impossible to arrange new polypropylene pipes in the halls next to the basement, plastic pipes were joined again to old distribution pipes of steel. It was thus only a partial improvement. (See fig. 5 and 6).

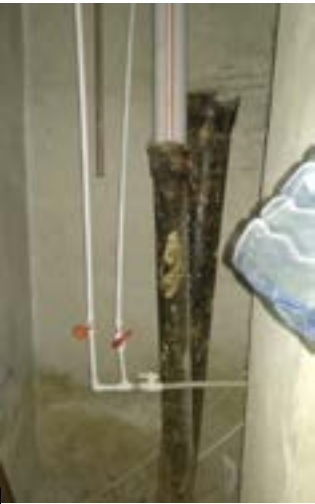
fig. 7

In the basement, all pipes, except for the one in the main collector, are made of cast iron. The cast-iron pipes pass through and above the first-floor flooring. Some of them running at the height of 1-1,2m and connecting to PVC (sewer plastic) pipes, while the majority of cast iron pipes have been left untouched (see fig. 7).

Apart from that, next to 100 mm sewer pipes, there are 150 mm diameter rainwater pipes, which are not functioning. Most of these pipes on the upper floors have been dismantled; only the ones on the first-floor level, going down to the basement level, remain (see fig. 7).

iron pipes are connected to a rainwater pipe, instead of sewer, and sewage waters likely discharge into the central rainwater system, instead of sewers (see fig. 7).

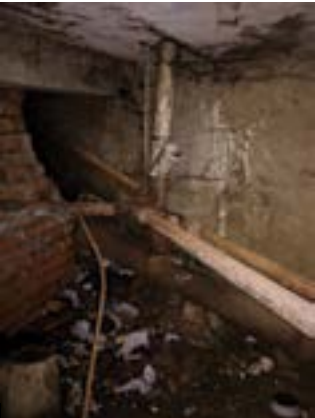
fig. 9

Besides, the pipes are damaged and most likely blocked at this point, due to which, during water consumption, part of sewage water leaks through pipes. The foundation becomes wet with sewage water at this place (fig. 9). It is also aggressive to concrete and reinforcement.

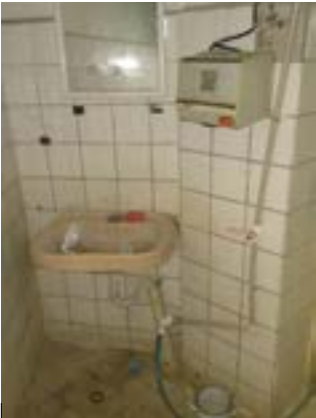
fig. 10

Toilet facilities on the first and upper floors in the section used by the Chess Federation are made of new materials, according to modern designs using, but the toilet on the backstage of the Main Hall is in a bad shape. It is most probably out of use now (fig. 10). In addition to that, several sewer pipes go down the backstage of the Main Hall and are done without proper designs. Other pipes pass through narrow service openings in the walls, which are full of garbage. Some of the pipes are new, while some are old and need to be replaced.

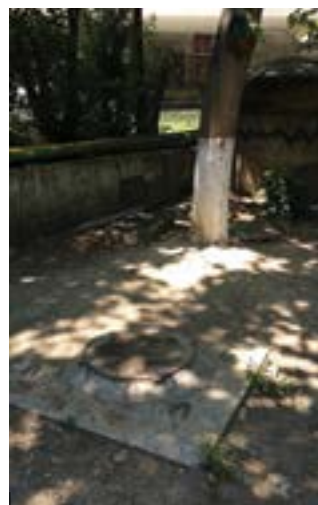
fig. 18

From the sewer pipe outside the building, water is discharged into sewage wells next to the parking lot in the backyard. One of the wells serves the facilities of the Chess Federation (fig. 18), and the other – those of the Alpine Club.

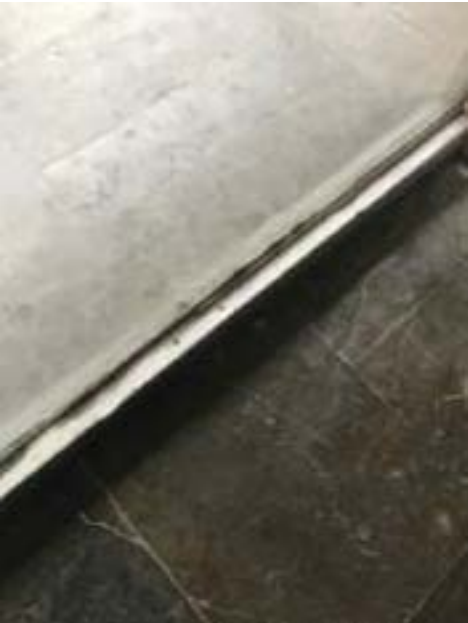
fig. 1

It should be noted that the vitrage is of low quality, and incorrectly installed. Single glazing with glass with a thickness of 6 mm is used, the frames are metal in some places, the rest is an aluminum profile, steel angles are used to fix the glass (photo # 1), which are attached to the frame with self-tapping screws. Isolation is practically not used. Such a construction is characterized by low energy efficiency due to high heat losses and intense infiltration.

The heat loss of the building is comparable if modern structures and materials are used in the Aluminum Vitrage windows. The comparison shows that heat losses are reduced by 3 times. This is the most important issue for improving energy efficiency.

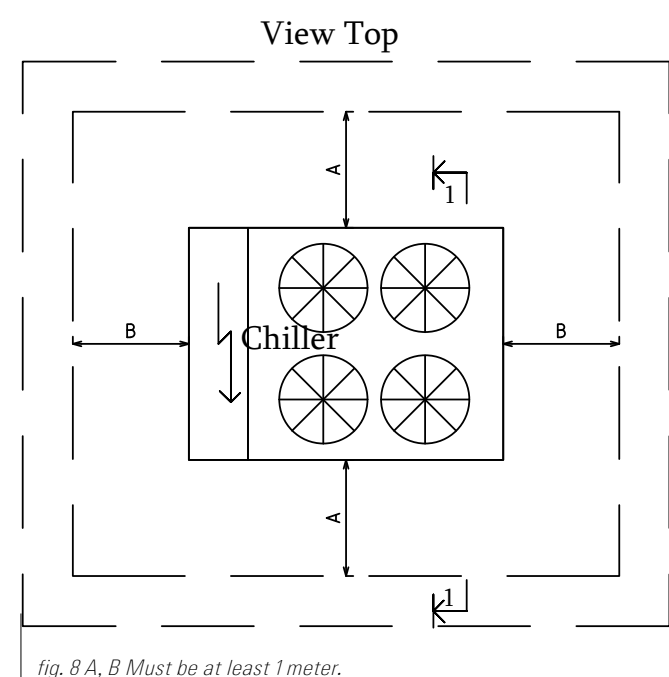
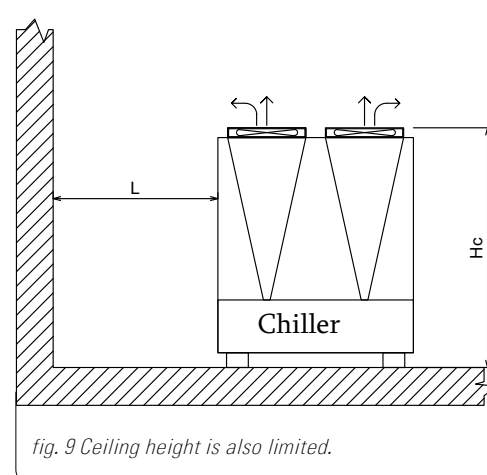
Only one central air conditioning system is installed in the billiard room in the northern half of the building. It is assembled according to the classic scheme: chiller + heating boiler + central ventilation unit + cassette type fan coils.

Much depends on the correct installation of the chiller for smooth and efficient operation. In particular, since the principle of operation of the existing chiller is to exchange excess energy with the external space, the exchange must take place without interruption, for this, all manufacturers specify the minimum distance to walls, ceilings, etc. in the installation instructions.

Both of these restrictions were violated during the installation of the existing system. As a result, the energy efficiency of the chiller is lower than that invested by the manufacturer and the output power of this unit cannot be used properly.

In addition, due to working in the wrong mode, there is a high probability of damage to the unit.
